FUNDAMENTAL INVESTIGATIONS ON CORROSION DETERIORATION OF STEEL STRUCTURES(Dissertation_全文)

RUNGTHONGBAISUREE, Somkiat

December 1990

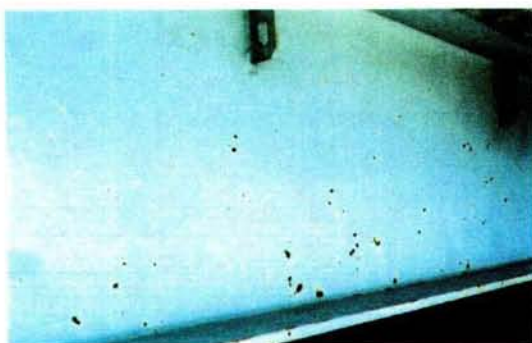
RN 2

Fig. 3.3 Examples of actual condition of paint film for each rating number of paint film deterioration

Fig. 3.2 shows area percentages of defect (rust) for determining the rating number of paint film deterioration. Examples of the actual condition of paint film deterioration for each rating number are shown in Fig. 3.3. Based on this rating number system, data of paint film deterioration of about 250 steel bridges in Japan were collected for each atmospheric environment and bridge member. Bridge members are classified into 26 different parts as shown in Fig. 3.4. These collected data of paint film deterioration are shown in Table A1s to Table A9s in the appendix. Rating number of steel corrosion, which will be discussed later in Chapter 4, are also shown in these tables.

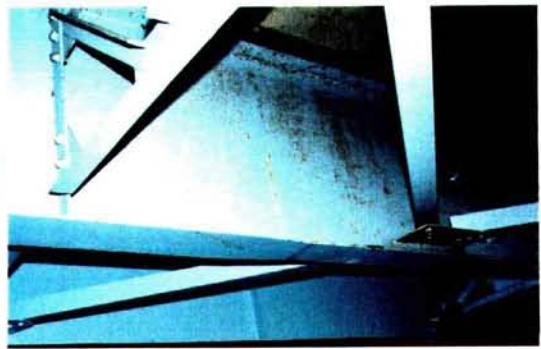
RN B

Fig. 4.4 Examples of actual condition of steel surface for each rating number of steel corrosion

Examples of actual condition of steel corrosion for each rating number are shown in Fig. 4.4. Based on this rating number system, corrosion deterioration of 216 road bridges and 33 railway bridges in each environment were qualitatively measured for 26 different parts of a bridge. These collected data of steel corrosion for each environment and bridge member are shown in Table A1s to Table A9s in the appendix together with the data of paint film deterioration. Table A11s show the history of paint for each bridge. Fig. 4.5 shows one example of the plot showing the relationship between RN of steel corrosion and accumulated exposure time after paint life. White circles represent the data of normal areas while black circles represent the data of water leaky areas. Exposure time is the accumulated time after paint life.
